Boiling-Water Reactor Internals Aging Degradation Study

Phase 1

Oak Ridge National Laboratory

NUREG/CR-5754
ORNL/TM-11876
RV

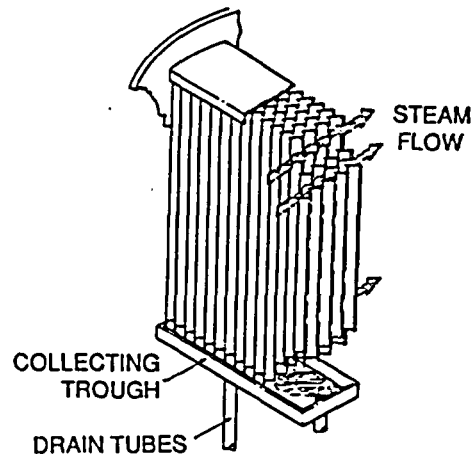
Figure 2.2 Steam dryer assembly

Description: The steam dryer assembly consists of the drying vanes and the top and bottom structural support members. They form a single structural unit that is mounted above the steam separators. The entire unit is supported by brackets extending inward from the pressure vessel wall. The moisture removed by the dryer is carried by a system of troughs and drains to the downcomer, which is the annular space between the core shroud and the pressure vessel wall. A sketch of a steam dryer unit is shown in Fig. 2.2.

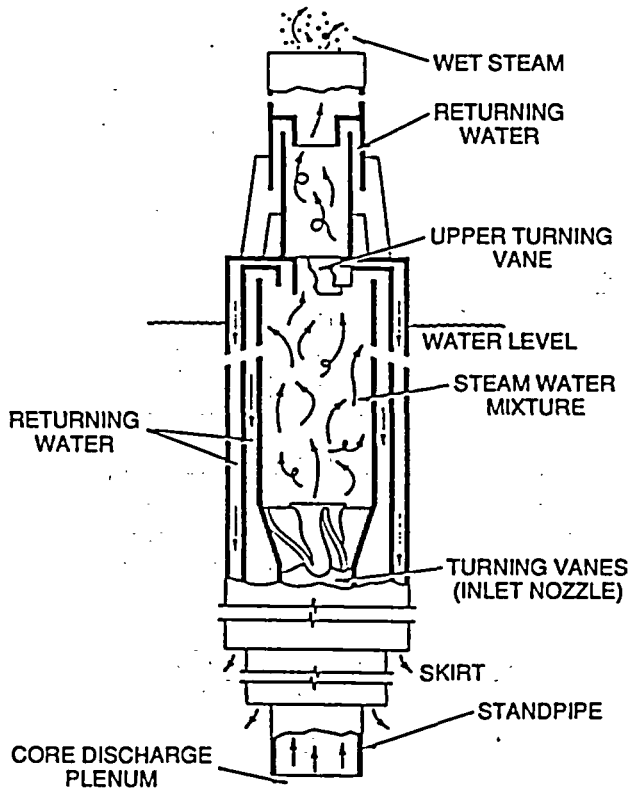
Figure 2.3 Steam separator assembly

Function: The steam separators separate water droplets from the steam in the steam-water mixture generated in the core.

Material of Construction: Standpipes and steam separators are made of type 304 stainless steel.

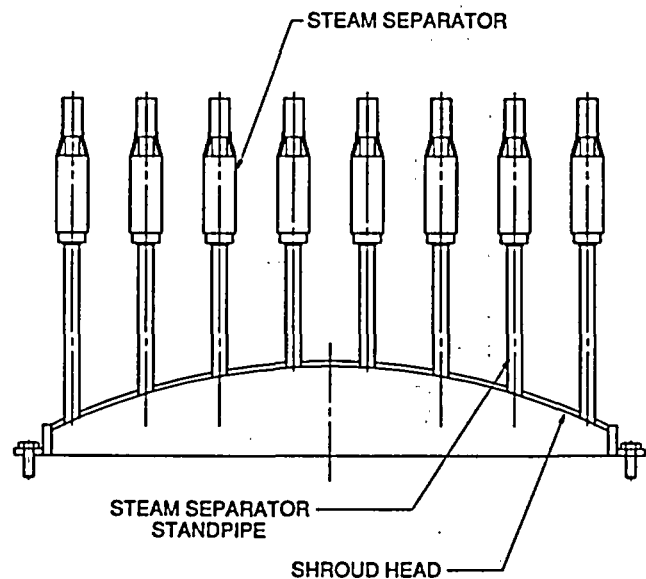
Figure 2.4 Shroud head

Material of Construction: The shroud head is made of type 304 stainless steel.

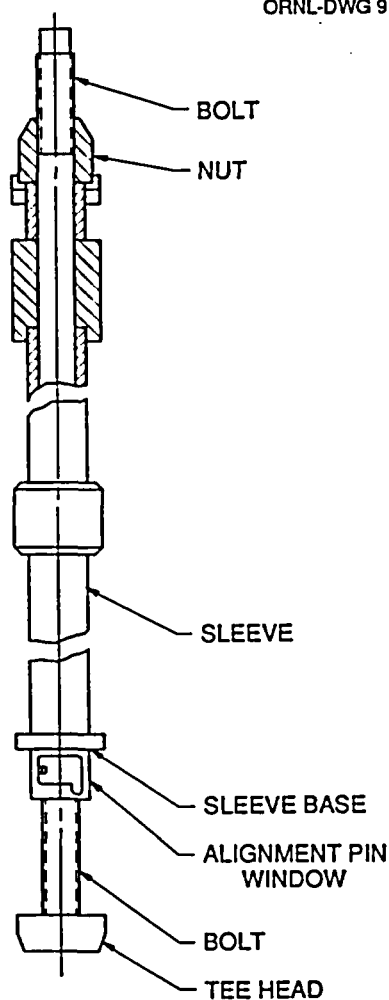
Figure 2.5 Shroud head bolt

Material of Construction: The bolt, the nut, and the tee head are made of Inconel 600 alloy. The sleeve and the collar are made of type 304 stainless steel.

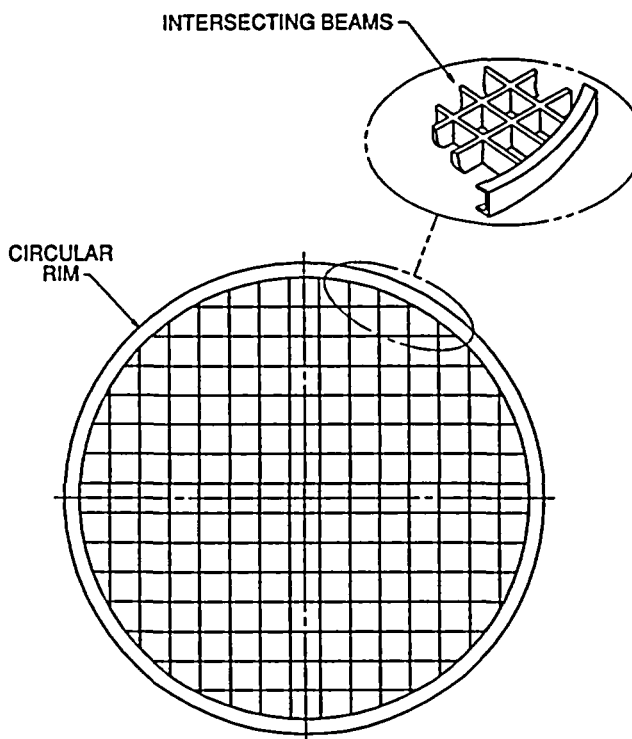
Figure 2.6 Top guide

Description: Top guides, with the exception of those in BWR-6s, are made by welding intersecting steel beams to a circular rim. At the intersecting joints, the upper beams have slots cut on the lower part, and the lower beams have slots cut on the upper part. The upper and lower beams are interlocked to form the grid. A crevice-free design, in which the rim and intersecting beams are machined from a single piece of steel, is used in BWR-6s. Each square opening formed by the intersecting beams provides lateral support and maintains proper spacing for four fuel assemblies. Holes are drilled into the bottoms of the beams, and they provide support to in-core neutron flux monitor dry tubes and the start-up neutron sources. The top guide is aligned by positioning pins that fit into slots in the top of the core shroud. A simplified sketch of a top guide is shown in Fig. 2.6.

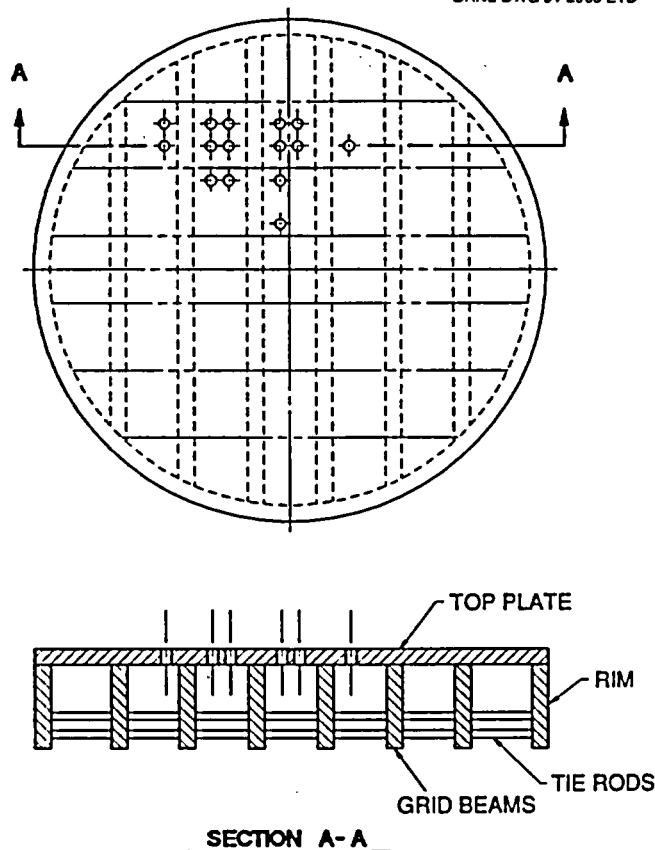
Figure 2.7 Core plate

Material of Construction: The core plate assembly is made of type 304 stainless steel.

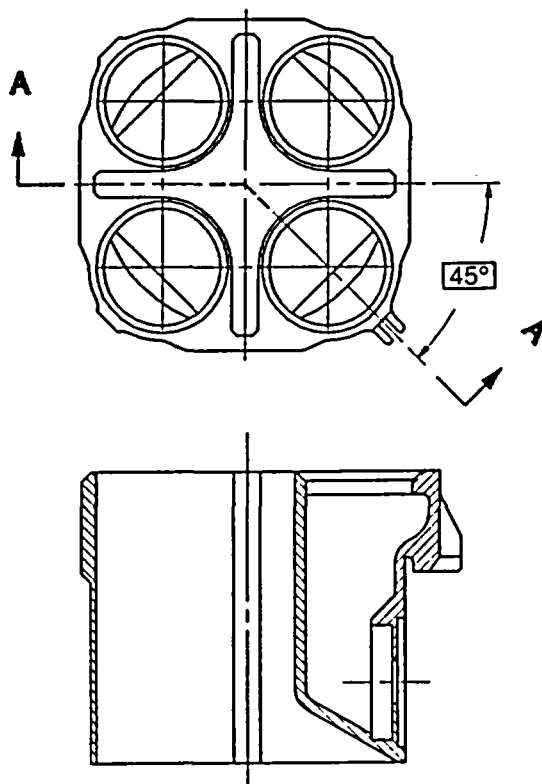
Figure 2.8 Standard OFS piece

Description: There are two types of OFS pieces. The standard or four-lobed OFS is a cylindrical structure with four internal compartments and a central opening for the positioning of a control blade. Each of the four internal compartments also has a lobe-shaped opening on the top surface. The standard OFS piece rests on top of a control rod guide tube. The bottom of a fuel assembly is inserted

into one of the lobe-shaped openings, and the OFS piece provides lateral support and alignment to the bottom of the fuel assemblies. The weight of the fuel assembly is transferred to the control rod guide tubes through the OFS piece. The coolant flow into the fuel assemblies is regulated by an orifice located on the side of the lower portion of the standard OFS piece. The peripheral OFS piece is a one-opening cylindrical structure that provides lateral support to only one fuel assembly. The peripheral OFS is welded to perforations in the core plate. The orifice of the peripheral OFS, which regulates coolant flow into the fuel assemblies, is located directly below the top opening. A simplified sketch of a standard OFS piece is shown in Fig. 2.8.

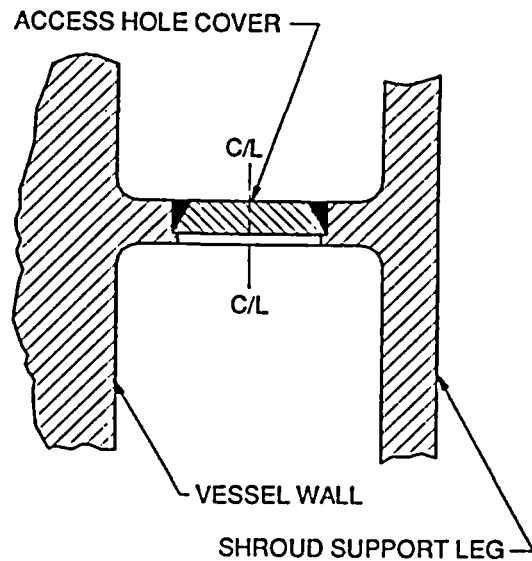
Figure 2.9 Access hole cover

Design Code: The access hole cover is designed to meet the requirements of Sect. III of the *ASME B&PV Code*.

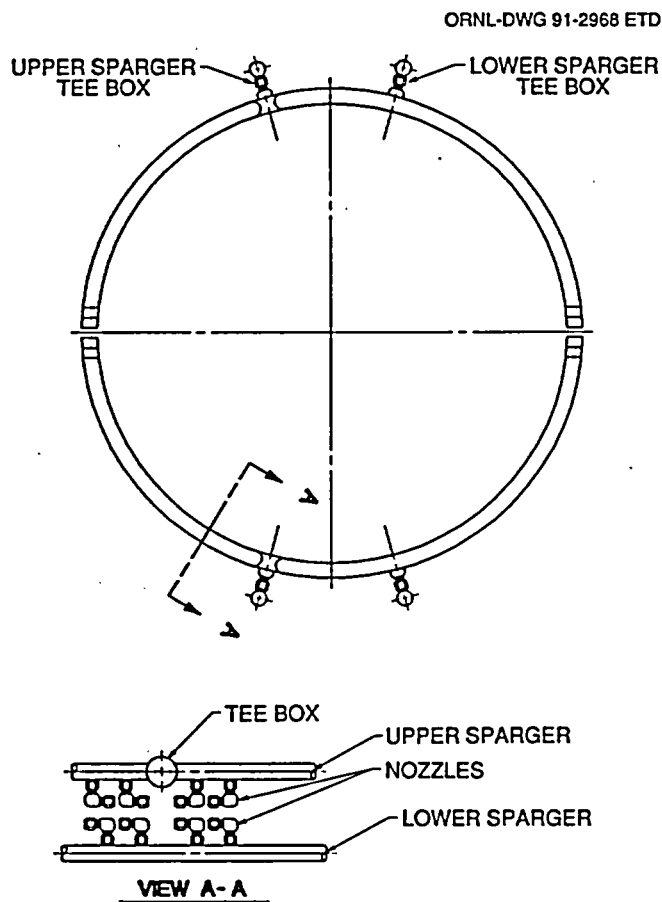
Figure 2.10 Core spray sparger

Material of Construction: The core spray sparger is made of type 304 stainless steel.

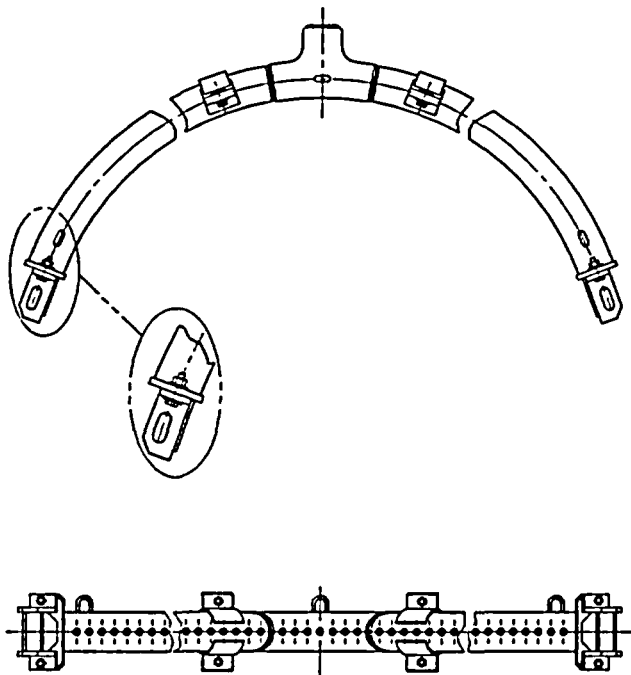
Figure 2.11 Feedwater sparger

Function: During normal operation, the feedwater sparger distributes cooler feedwater to the saturated reactor recirculating water before it comes into contact with the vessel

wall. The mixing of the two flows produces a flow of sub-cooled water to the jet pump and recirculation pump inlets and prevents the occurrence of pump cavitation problems. The homogeneous and uniform temperature mixture will also help to prevent the development of an asymmetrical power distribution in the reactor core. In the event of a LOCA, the feedwater sparger becomes a component of the High-Pressure Coolant Injection (HPCI) System. The HPCI System injects cooling water through the feedwater sparger into the core to maintain an adequate reactor water level in a LOCA.

Material of Construction: The feedwater sparger is made of types 316L and 316NG stainless steel.

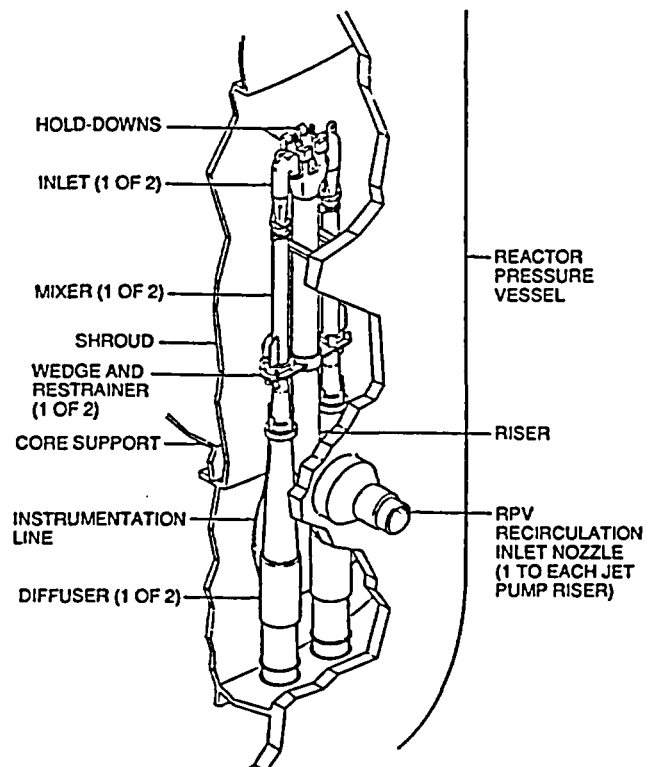
Figure 2.12 Jet pump assembly

The riser pipe receives high-pressure water from the recirculating water inlet nozzles and delivers the flow up to a transition piece casting. The flow from the riser pipe is turned downward into the driving nozzle by the inlet elbow. The high-speed nozzle exit flow entrains additional

cooling water through the suction inlet. The two flows mix in the throat or mixing section before discharge through the diffuser. The hydrodynamic forces acting on the jet pumps are reacted by holddown beams placed across the top of the transition piece casting.

Material of Construction: Most components of the jet pump are made of type 304 stainless steel. Parts that were cast, such as the transition piece casting and inlet elbows, are made of either Grade CF-3 or CF-8 steel. A portion of the diffuser is made of alloy 600. The holddown beam and two parts at the inlet of the mixing section are made of alloy X-750.

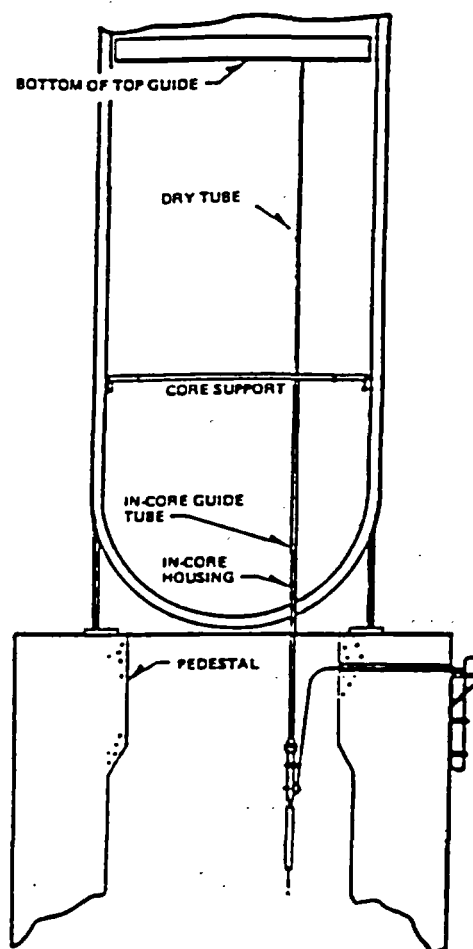
Figure 2.13 In-core neutron flux monitor

Material of Construction: The in-core neutron flux monitor housing is made of type 304 stainless steel.

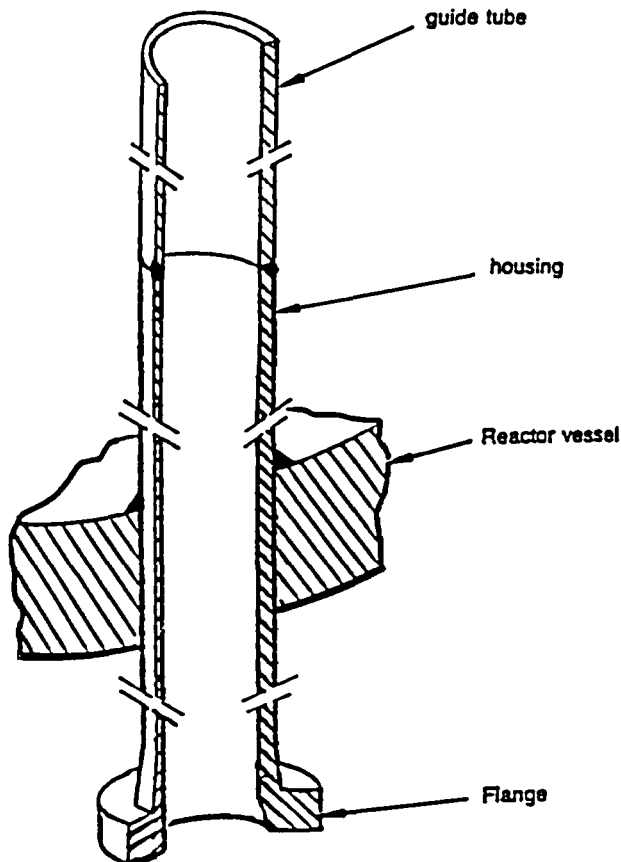
Figure 2.14 In-core neutron flux monitor housing and guide tube

Description: The in-core neutron flux monitor guide tube is a pipe welded to the top of an in-core neutron flux monitor housing. The pipe segment extends from the top of the neutron flux monitor housing to the top of the core plate. A latticework of clamps, tie bars, and spacers provide structural support to the guide tube. To prevent loosening during reactor operations, bolts and clamps used in building the support latticework are welded after assembly. The in-core neutron flux monitor guide tube is considered part of the reactor primary pressure boundary. A simplified sketch of the in-core neutron flux monitor guide tube is shown in Fig. 2.14.

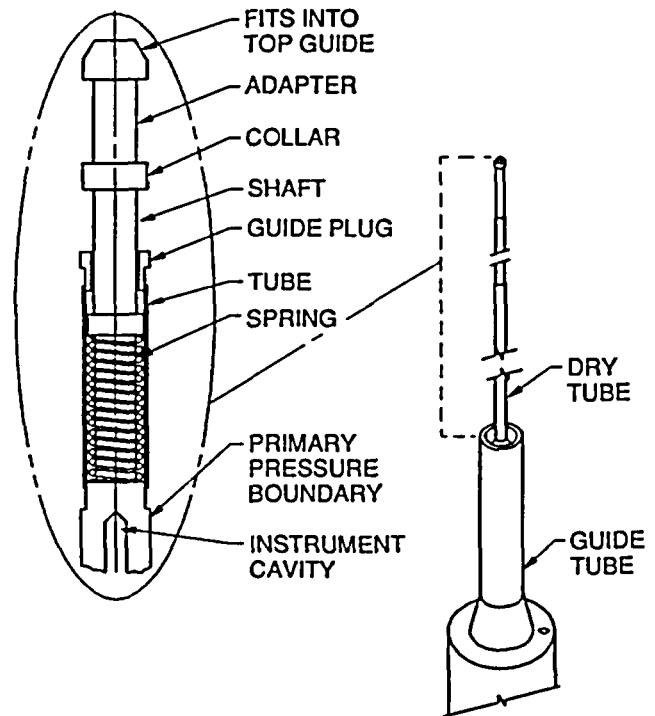
Figure 2.15 In-core neutron flux monitor dry tube

Material of Construction: The dry tube is made of annealed type 304 stainless steel.

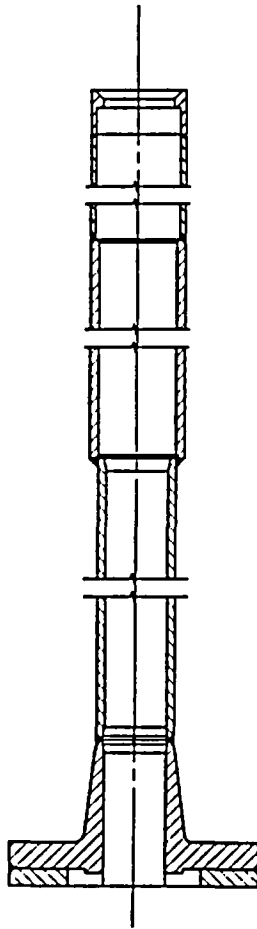
Figure 2.16 CRD housing

Function: The CRD housing provides access into the reactor pressure vessel for the CRD. It supports the CRD and the control blade. The CRD housing also provides the necessary restraint needed to counteract the forces caused by the activation of the CRD system.

Material of Construction: The CRD housing is made of type 304 stainless steel.

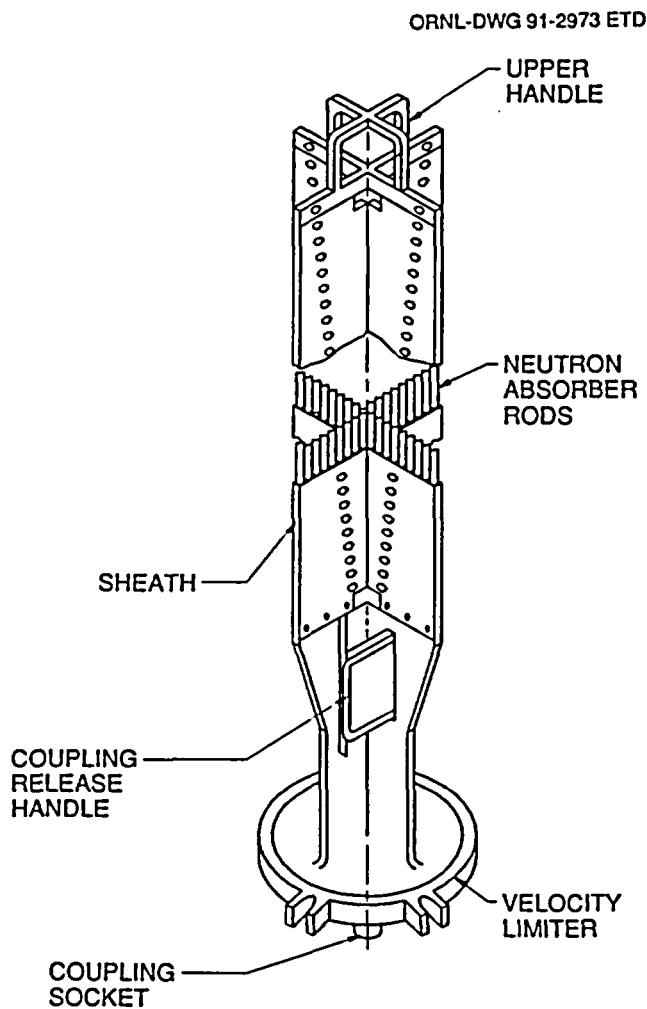
Figure 2.17 Control blade

Description: The major component of a control blade is the neutron-absorbing rod assembly. Neutron-absorbing rods are made of stainless steel tubings filled with boron-carbide powder. The tubes are seal-welded with end plugs at the two ends. The rods are held in a cross-shaped pattern by a steel sheath extending the full length of the rod. The sheath is spot-welded to the top of the tubes. An upper handle aligns the tubes and provides the necessary structural rigidity at the top of the rod assembly. The lower handle and the velocity limiter serve the same purpose at the bottom of the assembly. Control blades are inserted into the core from the bottom of the pressure vessel. A simplified sketch of a control blade is shown in Fig. 2.17.

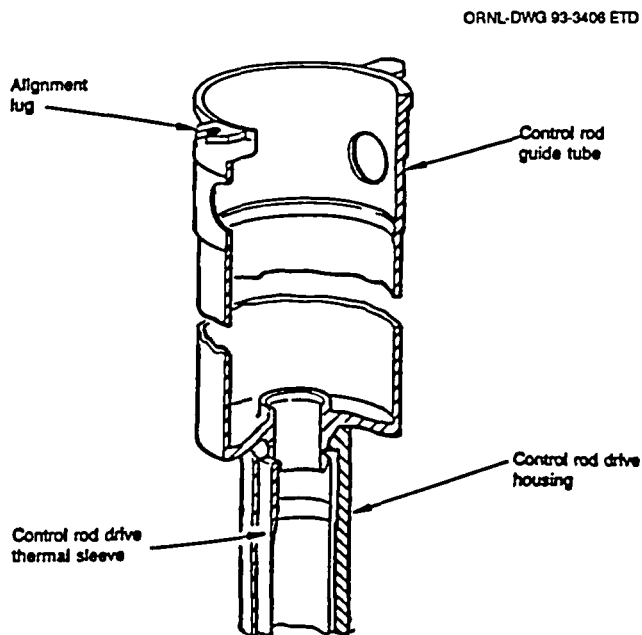
Figure 2.18 Control rod guide tube

Design Code: The control rod guide tube is designed to meet the requirements of Sect. III of the *ASME B&PV Code*.

Material of Construction: The control rod guide tube is made of type 304 stainless steel.

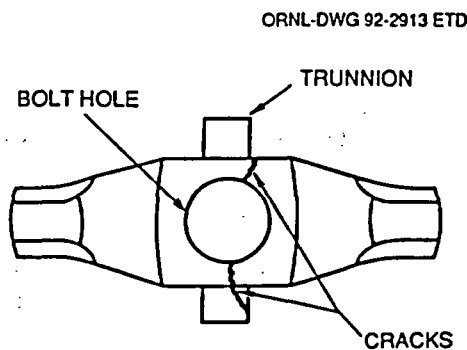
Figure 5.1 Crack locations of JET pump holddown beams

SCC was detected in jet pump holddown beams in six BWRs in the early 1980s. The beam is made of a nickel alloy (Inconel X-750). The cracks were located across the ligament of the beam section at the mean diameter of the bolt thread area as illustrated in Fig. 5.1. The cracks were intergranular. Low heat-treatment temperature (885°C), which led to the sensitization of the beam material, and high preloads on the beam bolt were major contributing factors to the development of SCC in jet pump holddown beams. Replacement holddown beams and beams in later models of BWRs are solution heat-treated at a higher temperature (1090°C), and preloads in the beam bolts were also reduced. These measures were effective in preventing IGSCC problems in new holddown beams.

A failure of the holddown beam could result in the disassembly of the jet pump and may also lead to a reduction of

the operation safety margin during postulated accident situations. NRC has issued IE Bulletin No. 80-07 (Ref. 3) on IGSCC problems in jet pump holddown beams; also, the bulletin established requirements for the inspection of jet pump holddown beams during refueling outages.

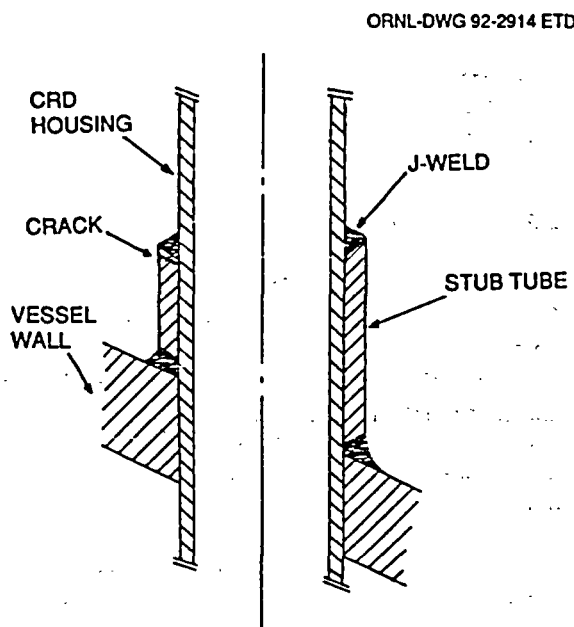
Figure 5.2 Crack in CRD stub tube

Leakage was attributed to the development of through-the-wall cracks in the stub tube in the vicinity of the J-weld that joins the CRD housing to the top of the stub tube. The cracks were intergranular. A typical crack is illustrated in Fig. 5.2.

The leakage was stopped by using mechanical seals sized to slip over the outer surface of the stub tube and by roll-swaging the CRD housing to close the gap with the vessel wall.

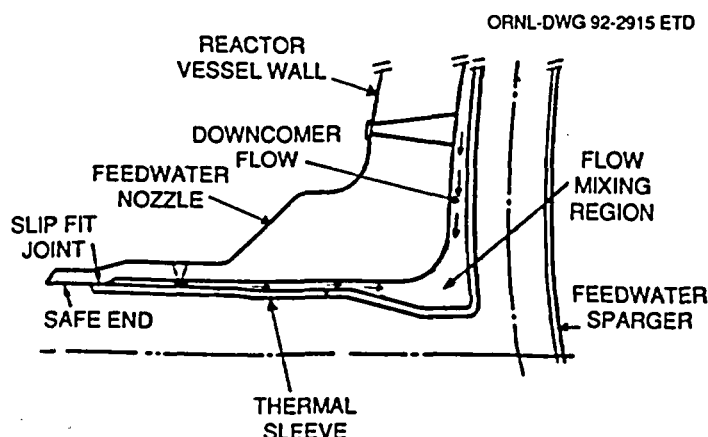
Figure 5.3 Feedwater sparger and feedwater nozzle connection

connection is shown in Fig. 5.3. In the original design, the slip fit joint is loose, and feedwater leaked into the narrow region between the outside surface of the thermal sleeve and the inside surface of the feedwater nozzle. Instability of the leakage flow caused the feedwater sparger to undergo vibrations. In addition, the cooler leakage feedwater is mixed with the hot recirculating downcomer reactor water in the region surrounding the sparger water inlet. Flow-induced vibrations and rapid thermal cyclings led to the development of fatigue cracks in the feedwater sparger and around the feedwater nozzle corner.

The feedwater sparger fatigue cracking problem was resolved by the implementation of a new sparger with a tight slip-fit joint, effectively reducing the leakage flow down to a very low and manageable level. A new feedwater nozzle was also used to prevent crackings in the nozzle with the new feedwater sparger design.
